Existing Environmental Conditions

Appendix
A

The analysis of existing environmental conditions at the former Allentown State Hospital (ASH) property was developed through review of publicly available environmental assessment reports. Since it is the current property owner's (the Commonwealth of Pennsylvania) intention to mitigate environmental concerns as part the site demolition contract, the Scope of Work for the Demolition Contract (DGS SOW) was also reviewed to determine if all previously identified environmental issues were being mitigated.

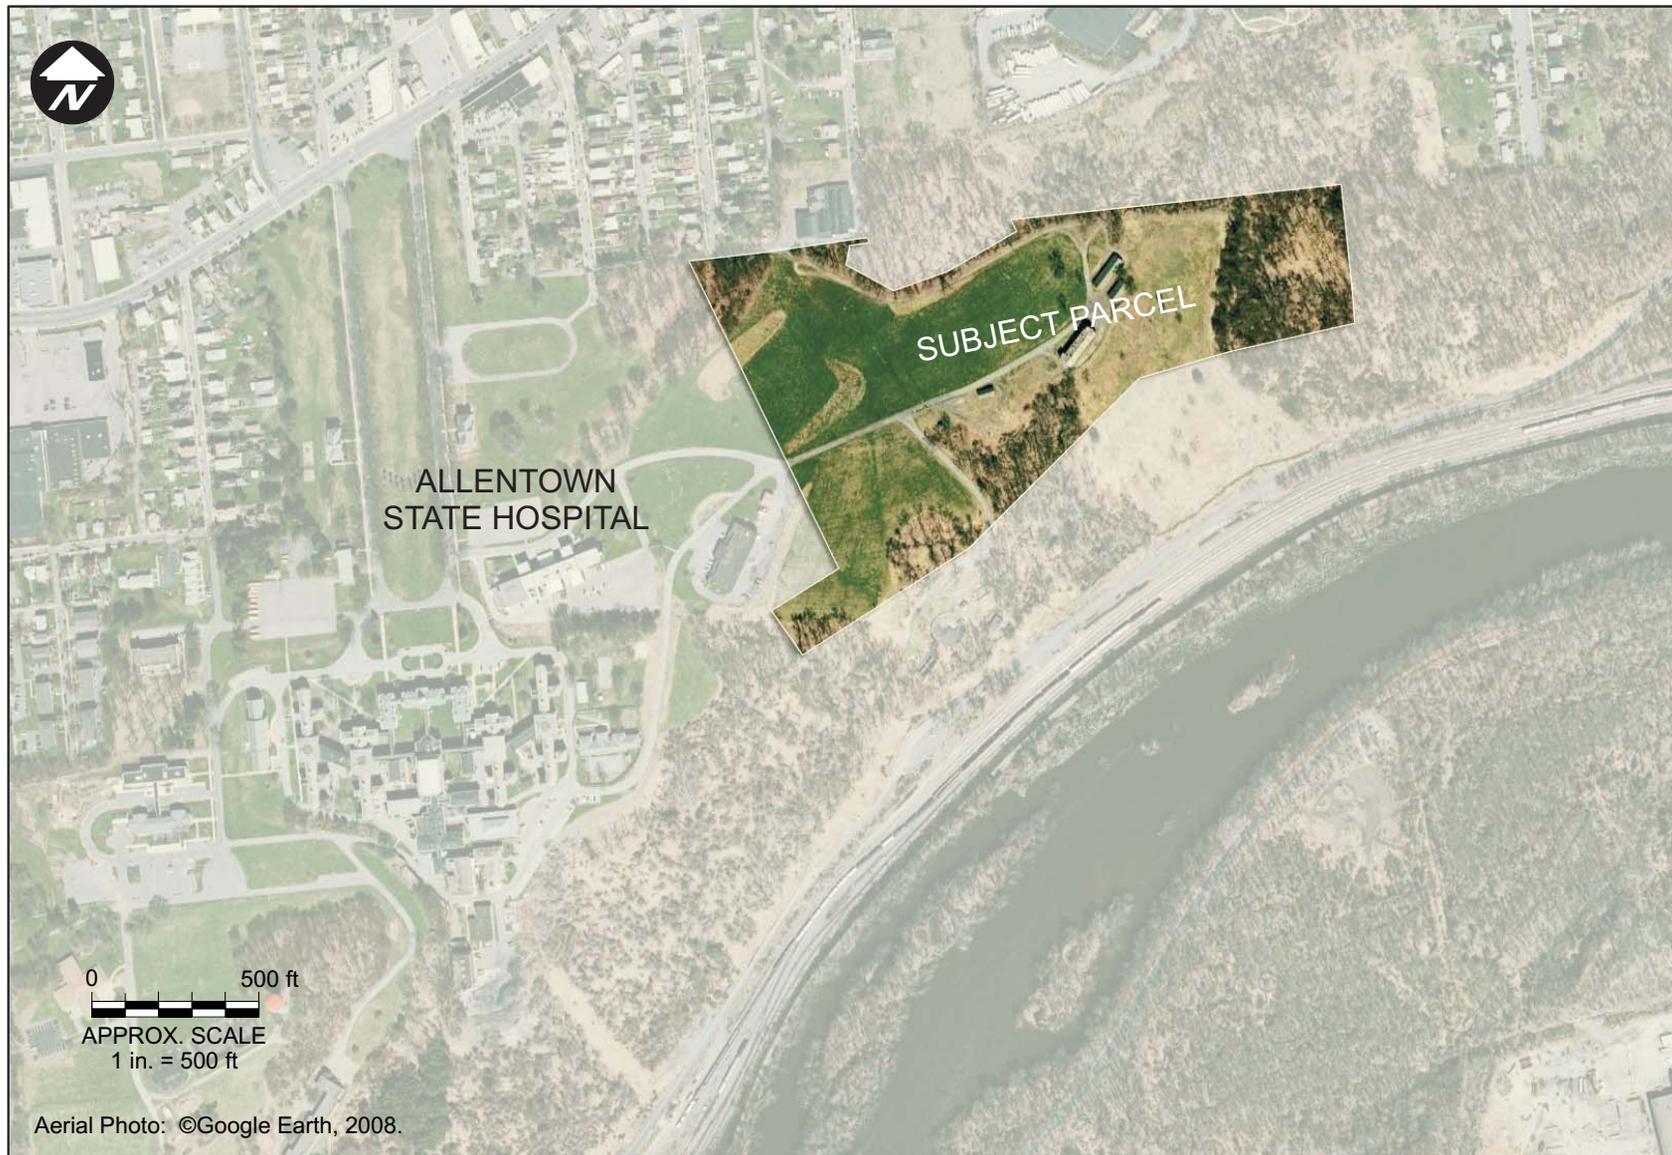
30-Acre Portion of ASH Now Located at 1900 East Allen Street (Former ACIDA Parcel)

1720 Spillman Drive Suite 280 Bethlehem, PA 18015-2165 ONE COMPANY Many Solutions™	Allentown State Hospital 1520 Hanover Avenue Allentown, PA 18109	Subject Parcel Phase I Environmental Site Assessment	Date	Figure
			1/16/09	2

Source: Phase 1 Environmental Site Assessment, prepared for the City of Allentown by HDR, Inc., February 24, 2009.

REPORT REFERENCED	PARCEL & PURPOSE	FIELD WORK CONDUCTED	RECS & IDENTIFIED CONCERNS	FIGURE REFERENCES	FINDINGS/ RECOMMENDATIONS AND FOLLOW-UP STUDIES	DGS PLANNED MITIGATION
1	Phase 1 Environmental Site Assessment, prepared for the City of Allentown by HDR, Inc., February 24, 2009.	30-acre portion of the ASH property now located at 1900 East Allen Street, also known as the former ACIDA parcel. The Phase 1 was conducted to support possible acquisition of the parcel by the ACIDA.	N/A	PADEP documents, interviews and aerial photographs indicate that several areas have been backfilled or show signs of soil disturbance. Specifically, documents indicate the eastern boundary of the subject parcel was utilized as a landfill starting in the early 1970s and into the 1980s. The fill material at these locations was never characterized and is considered a recognized environmental condition.	Figure 2 shows 30-acre parcel		See REC 4 from 2018 Phase 1

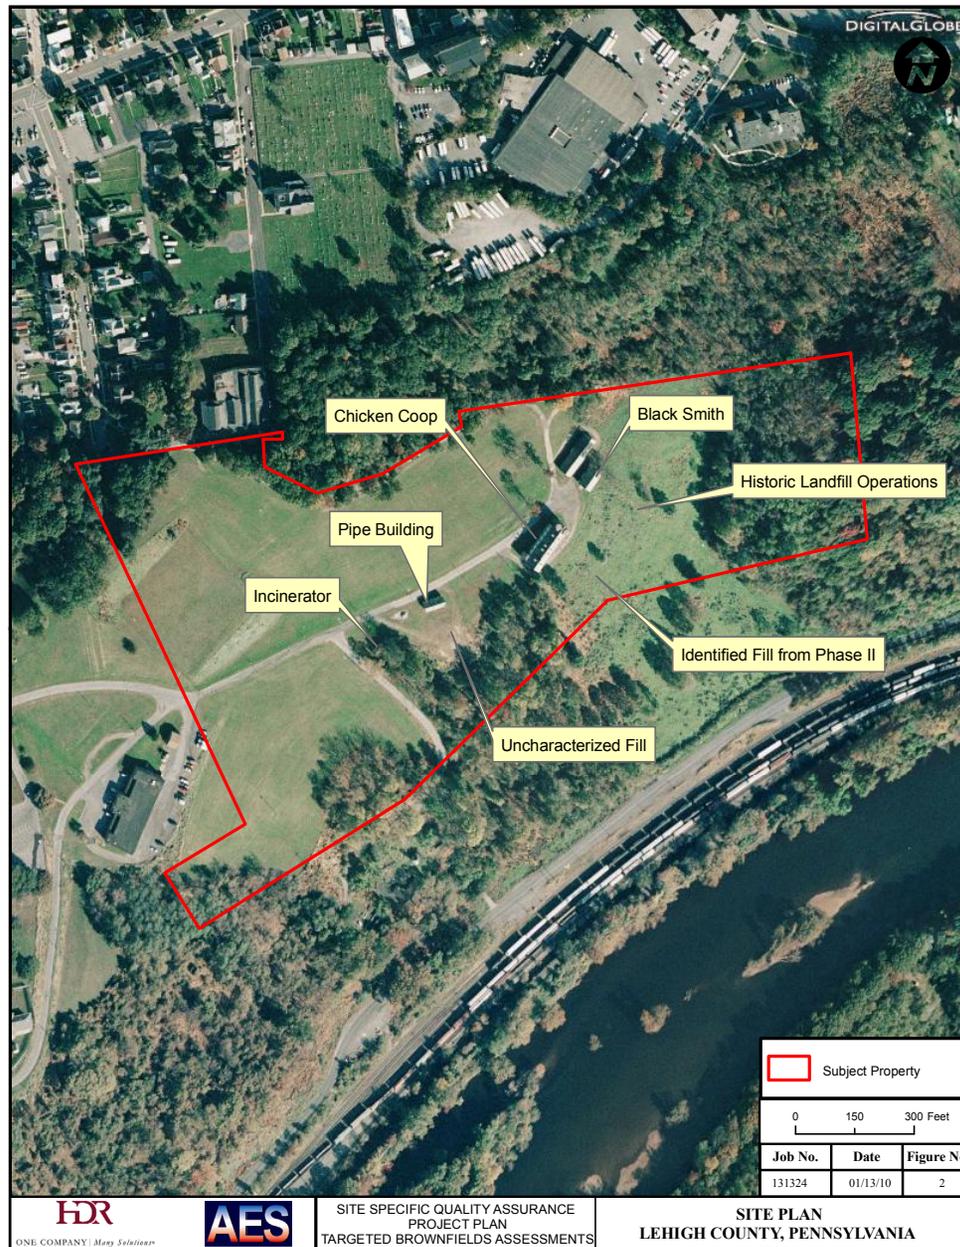
Areas of Concern for the Former ACIDA Parcel (Map 1)

Source: Target Brownfield Assessment (TBA), Subsurface Field Investigations, prepared for USEPA by Advanced Environmental Solutions, Inc and HDR Inc., September 2010.

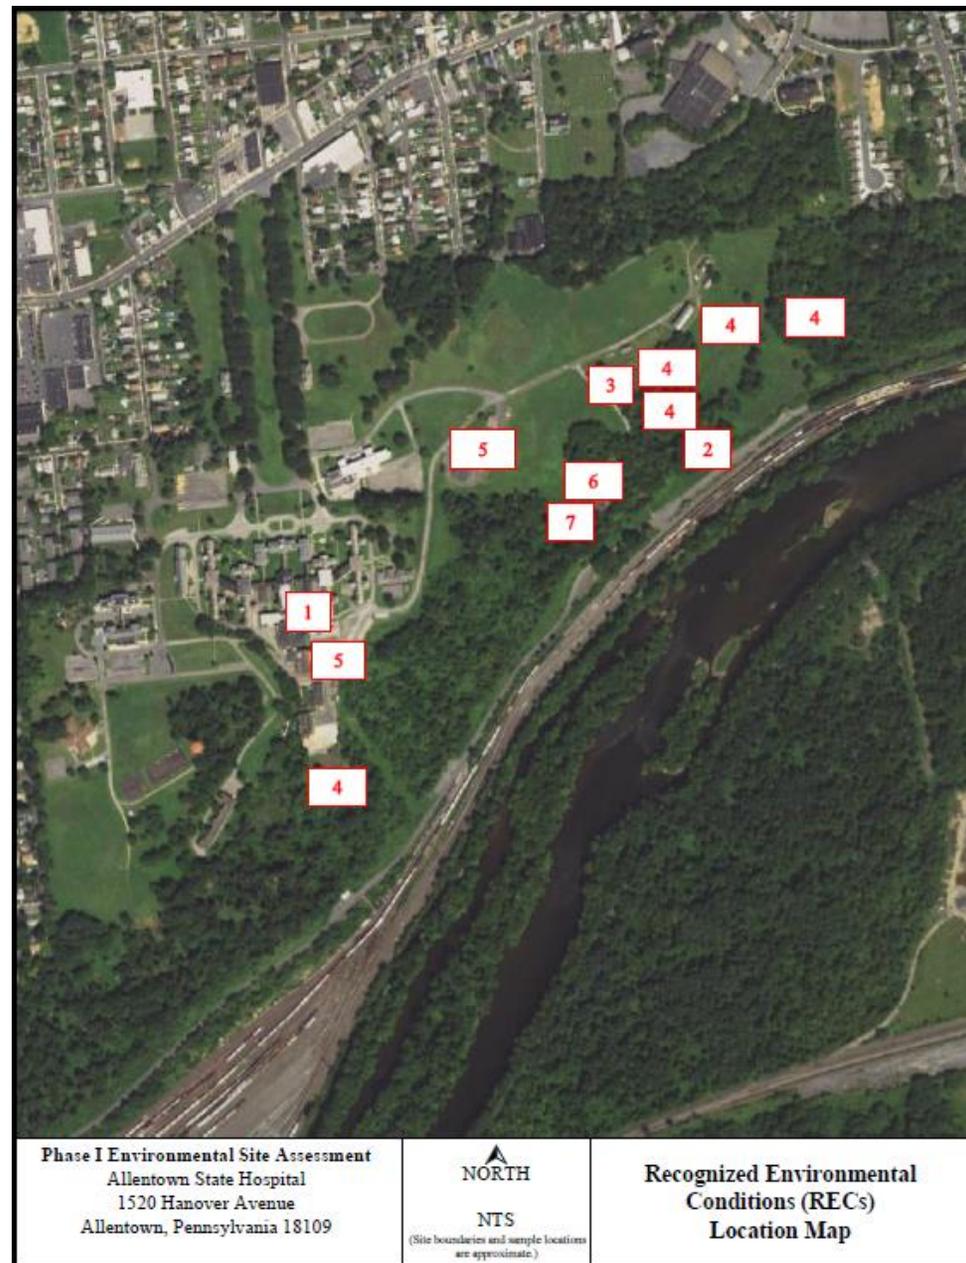
Areas of Concern for the Remaining 160-Acre Site (Map 2)

Source: Phase 1 Environmental Site Assessment, prepared for DGS by KCI Technologies, Inc., November 8, 2018.

REC 2 - Fire Training area east of WWTP.	Figure ES 1 2018 Phase 1 KCI		The Fire Training area east of the WWTP has the potential for soil contamination from byproducts of burning. DBC is to sample soils for TPH, VOCs, SVOCs, RCRA-8 metals, PFOS/PFAS and characterize and delineate contaminated areas and remove elevated contamination if present. DBC will remove rusted partial drums and large metal tank. Results and report(s) are to be prepared and shared with DGS hired QA firm.
				REC 3 - Coal Ash and dioxin soil contamination in area of former incinerator. 2018 KCI Phase 2 sampling confirmed dioxin levels.	Figure ES 1 2018 Phase 1 KCI	Previously Identified.	The DBC is to excavate and dispose of approximately 14 tons of known dioxin contaminated soil located south and southeast and of the Incinerator. DBC is to investigate, remove and dispose of additional apparent ash deposited near the northeast and northwest corners of the incinerator and remove if determined to be contaminated. DBC is to remove and dispose of ash remaining within the incinerator prior to demolition, and clean stained areas prior to demolition. DBC is to collect confirmatory samples following removal and provide and install clean backfill. DBC shall backfill and perform compaction associated with backfilling in these areas with clean fill.

<p>REC 5- Use and storage of chemicals, oils and evidence of vehicle maintenance in Electric Shop and Maintenance Shop</p>	<p>Figure ES 1 2018 Phase 1 KCI</p>	<p>Previously Identified.</p>	<p>Containers of lubricants, motor oils, paint, vehicle/equipment maintenance chemicals, and tires are present in the electric shop and maintenance shop at the subject site. Oil staining was observed around several transformer/electrical parts on the concrete floor in the electric shop and around equipment in the maintenance shop. DBC is to dispose of containers and all remaining chemicals, lubricants, containers and tires prior to demolition of the shops. DBC is to clean stained areas or remove substrate and dispose prior to demolition of the shops.</p>
